**INSTALLATION & MAINTENANCE MANUAL
for Composite Tail Rotor Blade
Part Number AMT-206-1
Supplemental Type Certificate SVR 520**

Tail Rotor Blade AMT-206-1

Document No. CTRB-IMM

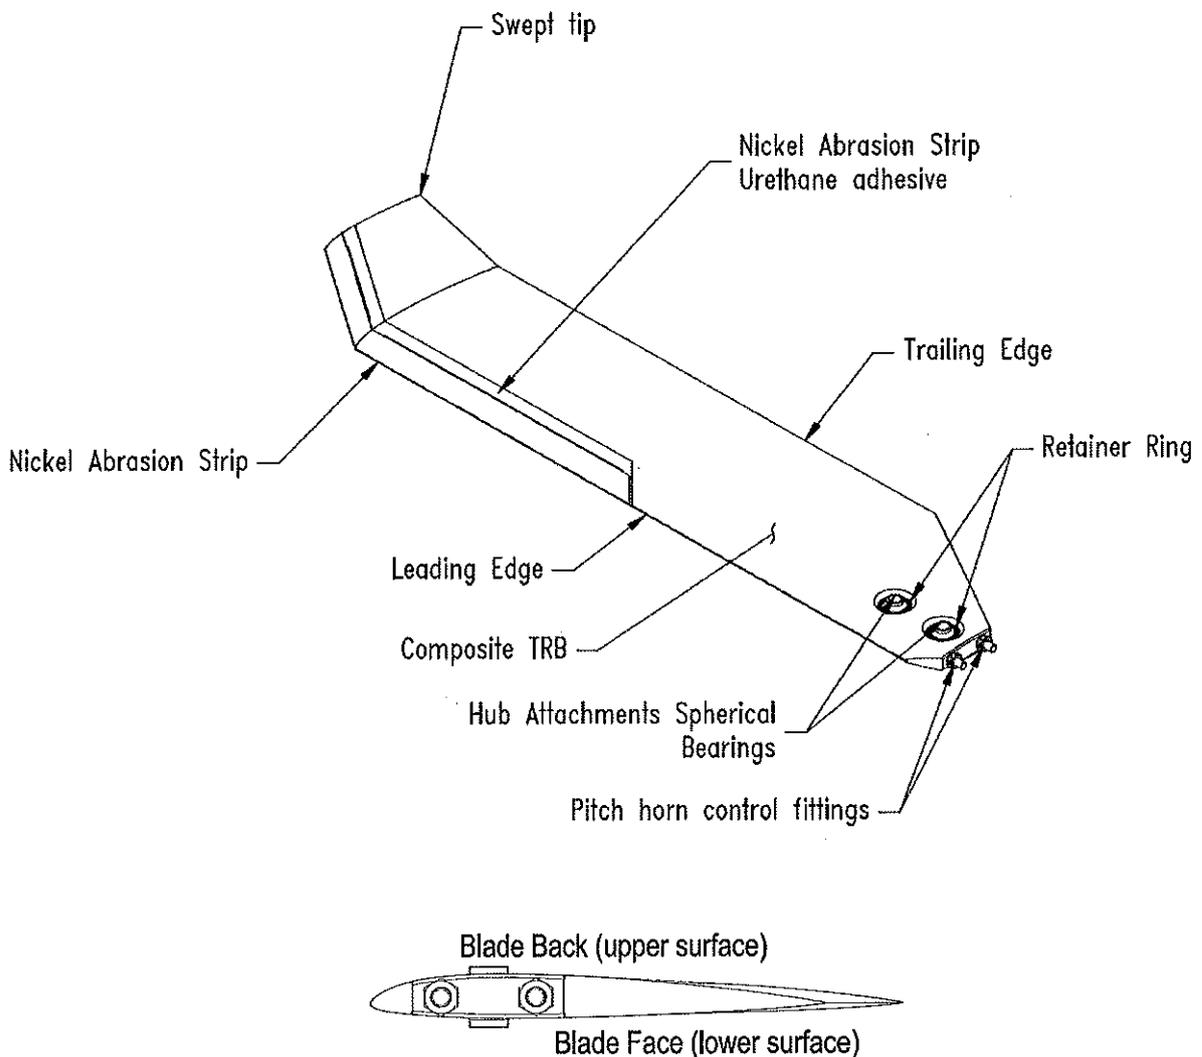
Figure 1 – Blade Overview

The AMT-206-1 composite tail rotor blade is direct replacement for the Bell 206 TRB. The AMT-206-1 TRB has a non-symmetrical airfoil section and incorporates a swept tip. The blade is primarily fabricated from uni-directional Graphite and Aramid continuous fibres suspended in an epoxy matrix and is fitted with a nickel abrasion strip on the leading edge. The abrasion strip is bonded on using a urethane adhesive.

The AMT-206-1 tail rotor blade is designed around a mix of aramid, carbon and glass fibres that are bound in an epoxy matrix. The design incorporates a stainless steel mesh embedded in the surface coat to provide lightning protection

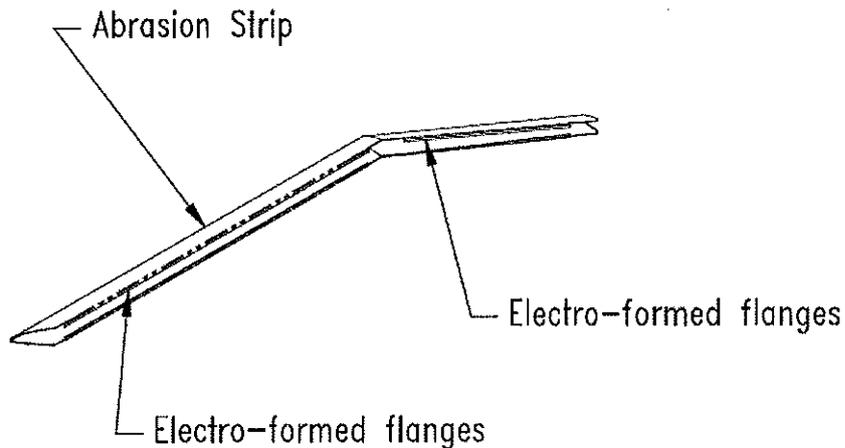
Figure 2 – Nickel Abrasion Strip

AMT-206-1 blades are equipped with a nickel electroformed abrasion strip. The abrasion strip incorporates a unique design by A.M.T. Helicopters Pty Ltd in where there is a mechanical tab along a large portion of the abrasion strip, which mechanically fastens the abrasion strip to the urethane adhesive, consequently the nickel strip is held both by adhesion and mechanically.

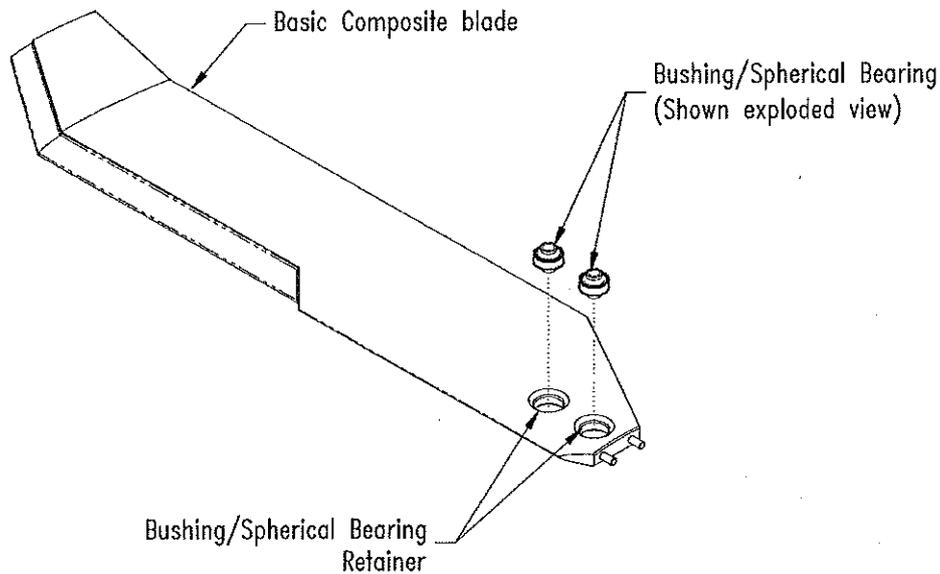
Figure 4 – Spherical Bearings (Blade Installation)

The blade is fitted with two HAC-SSW Spherical Bearings which permit the blade pitch angle to be adjusted. The two Spherical Bearings are NOT field replaceable and may only be replaced by the factory (A.M.T. Helicopters Pty Ltd) using procedures and tooling approved by A.M.T. Helicopters Pty Ltd.

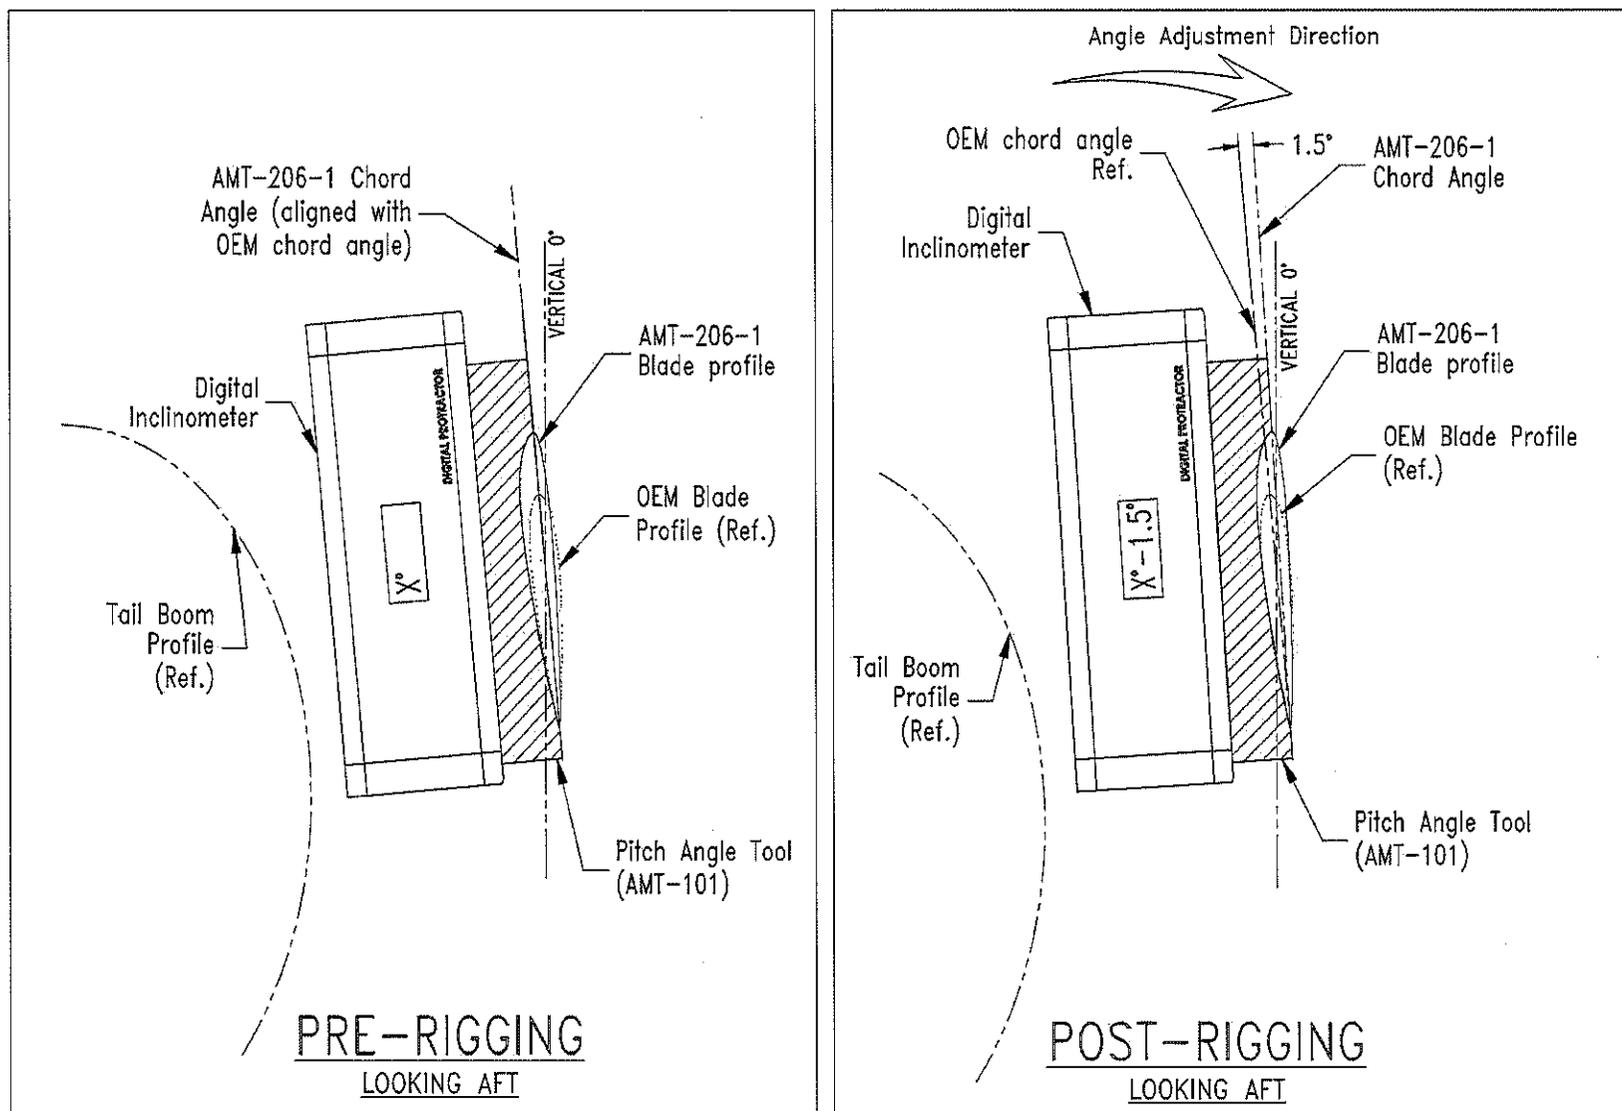
Figure 7: Tail Rotor Blade AMT-206-1 Rigging

- f. Lock control rod #8 and re-secure per the B206 MM.
- g. Carry out a dynamic balance IAW the B206 MM, Chapter 67.
- h. Complete locking and safety inspections of the adjusted flight controls.

- i. Check full left and right pedal travel and ensure Tail Rotor Blade clearance from hub.

There are no unique installation requirements for the AMT-206-1 composite blade excluding the requirement for an adjustment in the neutral pitch angle (1.5 degrees). The blades should be fitted to the hub assembly IAW Bell 206 Component Repair and Overhaul Manual Latest Revision.

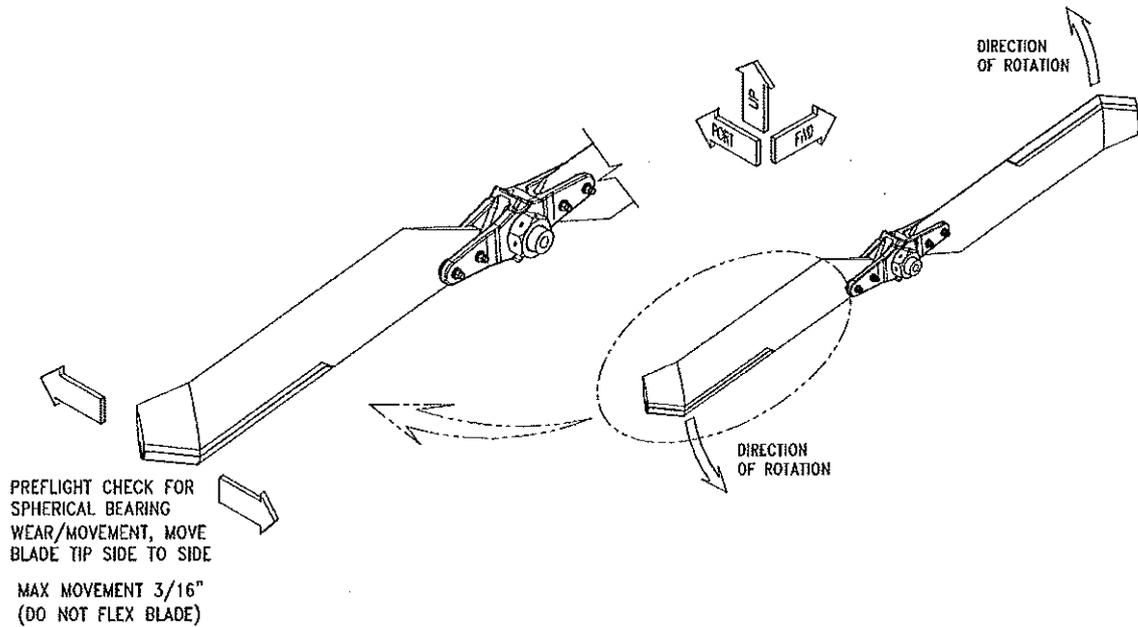
Figure 8: Preflight Spherical Bearing wear/movement Check

- b. Check for Spherical Bearing wear by immobilising the hub with one hand and moving the blade tip perpendicular to the blade surface (side to side). A maximum of 3/16" travel (at the tip) is permissible, this corresponds to a maximum spherical bearing ball movement of 0.005" and is a suitable means for an on aircraft determination of the wear / movement of the spherical bearings. Where doubt exists maintenance personnel are to be notified. Refer to 5Figure 8: Preflight Spherical Bearing wear/movement Check.

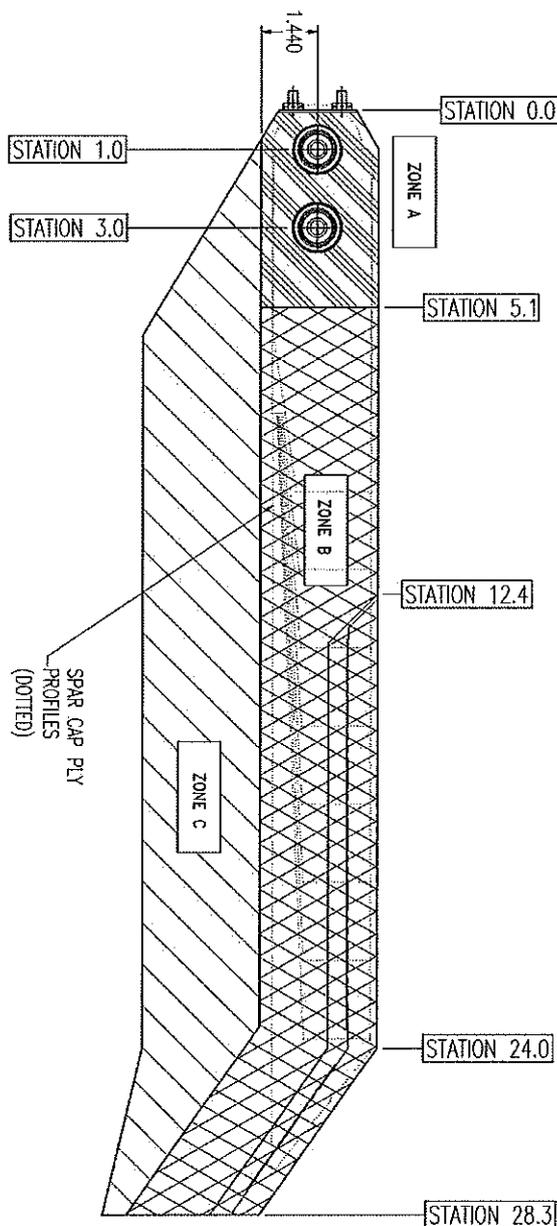
Figure 9: Tail Rotor Blade AMT-206-1 Zone Definition

- i) Inspect around each Spherical Bearings / retainer ring cavity (Zone A) for cracks on both surfaces. No cracks are permitted. If there is a crack the blade is **NOT AIRWORTHY**.
- ii) Inspect the blade at STA 3.0 (inline with the outer attachment Spherical Bearing) (Zone A) for cracking. No cracks are permitted
- iii) Inspect the rest of the blade for cracks (Zone B and C) . No cracks are permitted.
- iv) Where a crack is found and suspected to be in the paint work only, perform an inspection using the tap-test method, refer to *FAA Advisory Circular AC43.13-1B, Change 1, September 08, 1998 (or latest revision) Section 8. Tap Testing* to verify cracking is only in the paint work and not the substrate structure. Where doubt exists, the factory is to be contacted for assessment.

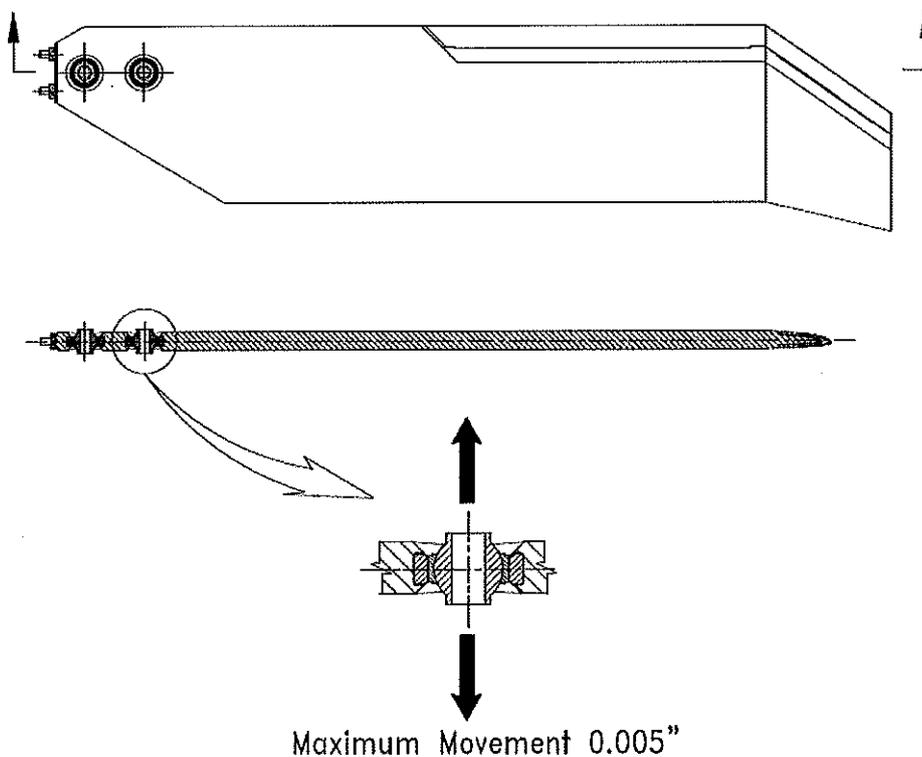
Figure 10 – Permissible Spherical Bearing movement

- i) Visually inspect torque-lock paint (applied between the spherical bear race and retaining ring) to ensure the Spherical Bearings (Body) has not moved from the retainer ring. No movement is permitted. If there is indication of Spherical Bearing movement with respect to the retainer ring the blade is **NOT AIRWORTHY**. The blade must be repaired by the factory if deemed possible.
- ii) Place the blade in a soft jaw vice secured by the Spherical Bearing end flanges (the ball). Check for Spherical Bearing wear by trying to move the blade from side to side (attempting to translate the Spherical Bearing ball out of the race and blade). No movement over 0.005" is permitted. If there is an indication of movement greater than 0.005" the blade is **NOT AIRWORTHY** and must be repaired by the factory if deemed possible.
